TEST RESULTS

Fiat 500X Small MPV

Tested Model	Fiat 500X 1.6 diesel 'Pop Star', LHD
Body Type	5 door hatchback
Year Of Publication	2015
Kerb Weight	1386kg
VIN From Which Rating Applies	all Fiat 500X's of the specification tested
Class	Small MPV

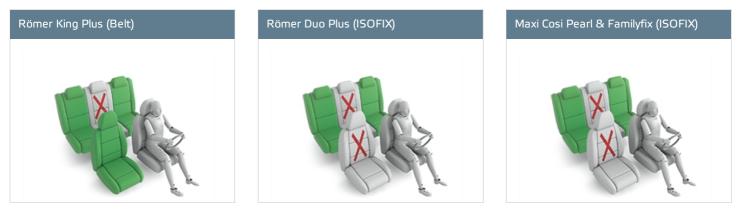
The 500X scored maximum points for its protection of the 1½ year dummy in the dynamic tests and lost only a fraction of a point for the 3 year dummy, for chest acceleration slightly over the good performance limit. Both dummies were sat in rearward-facing restraints. In the side impact, both were properly contained within the protective shells of their restraints, minimising the likelihood of head contact with parts of the car interior. The front passenger airbag can be disabled to allow a rearward-facing child restraint to be used in that seating position. Clear information is provided to the driver regarding the status of the airbag and the system was rewarded. All of the child restraint types for which the car is designed could be properly installed and accommodated in the vehicle.

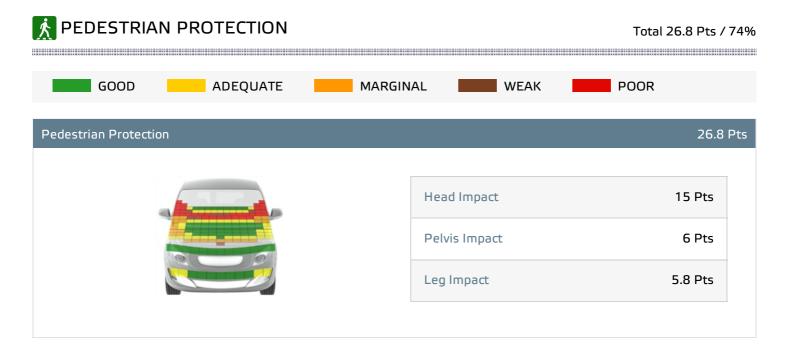
The bumper provided predominantly good protection to pedestrians' legs. Protection of the pelvis area was good and the car scored maximum points in these tests. The bonnet surface provided predominantly good or adequate protection to the head of a struck pedestrian, with poor results recorded along the edge of the windscreen and on the stiff windscreen pillars.
