## Mitsubishi L200

Pick-up

2015

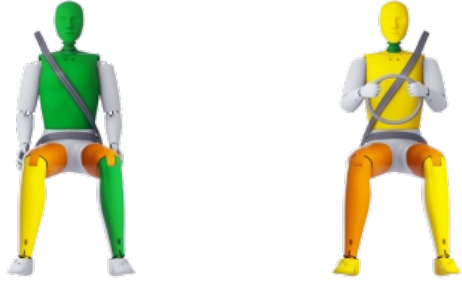
Frontal Offset Deformable Barrier 5.3 Pts

Passenger Driver

In the frontal offset test, there was extensive deformation of the bodyshell. There was a rupture of the floorpan in the driver's seating position, considerable buckling of the floor in the rear of the passenger compartment and spot welds had failed at the point where the bottom sill meets the C-pillar (the rearmost pillar of the passenger compartment). The car was penalised for this and Mitsubishi were precluded from demonstrating that structures in the instrument panel, such as the steering column and column shroud, would not present a risk of injury to the knees and femurs of occupants in the front seats. Protection of the knees, femurs and pelvis was rated as marginal. There was also insufficient pressure in the airbag to prevent the driver's head from bottoming-out against the steering wheel. Dummy head readings showed that contact had been made with the steering wheel through the deflated airbag and protection of the head was downgraded to adequate. In the full width rigid barrier test, protection of the driver dummy was good for all critical body areas while, for the rear passenger, protection of the neck was adequate and that of the chest was marginal. In both side impact tests - the side barrier and more severe side pole - the L200 scored maximum points, with good protection of all critical body areas. The front seats and head restraints showed good protection against whiplash injury in the event of a rear-end collision and a geometric assessment of the rear seats also indicated good whiplash protection. The L200 does not have an autonomous emergency braking system to assist further in whiplash protection.

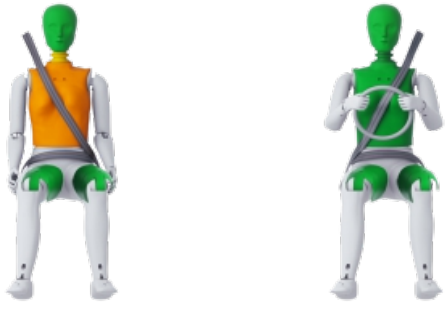
Frontal Full Width 7.1 Pts

Rear Passenger Driver
